Beech on a Budget

Landing Gear System Watch Outs

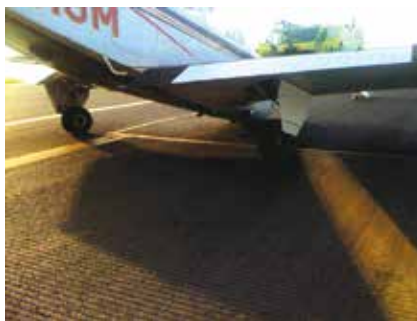
FIGURE 2

Figure 2 shows why rod ends are so important, and how running them beyond some reasonable service life is risking the totaling of your airframe or the high-dollar and lengthy downtime of extensive engine and airframe repairs. There are several recommendations on Time-in-Service (TIS) for rod end replacement, ranging from 2,000 hours in Beechcraft

service manuals, on up to 4,000 hours TIS by anecdotal references among owners knowledgeable of rod end failures. ABS strongly recommends observing the 2,000 hours TIS figure given service history and the airplane-totalling nature of rod end failure.

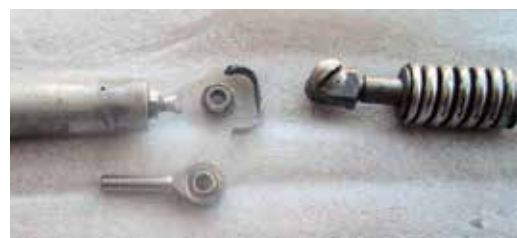
FIGURE 3

Figure 3 shows a failed nose gear rod end at approximately 7,000 hours TIS. Let's bite the bullet on these rod end failures, folks. Why don't we say that a rod end, that has delivered 2,000-4,000 hours TIS over multiple decades, has given an adequate service life and give the airframe that extra margin against an aging part failure?

... you are gambling on a failure that may result in a landing with the nose gear not extended! I was very fortunate; the aft nose gear retraction rod pushed the front nose gear retraction rod to lower the gear with the failed rod end. I felt a thump when I retracted the gear and didn't know what the problem was, so I extended the gear for the next landing, at home base, at under 100 knots and did a gentle, smooth landing and slow taxi to the hangar on smooth pavement. When we retracted the gear the next day on jacks, the nose gear did not retract. We were very lucky not to have landed the Deb with the nose gear not extended or in having it fail on the ground. Please do not neglect the nose gear retract rod ends. There are three of them.

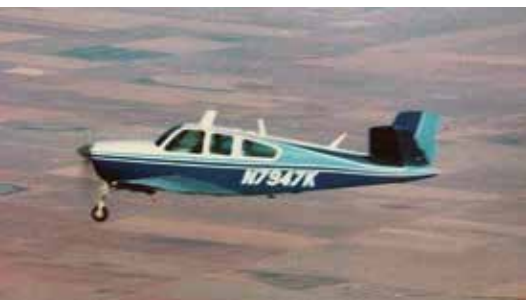
FIGURE 4

Speaking of nose gear not retracting, I'll describe another circumstance that could cause to the same thing to happen in early model Bonanzas, as shown in **Figure 4**.

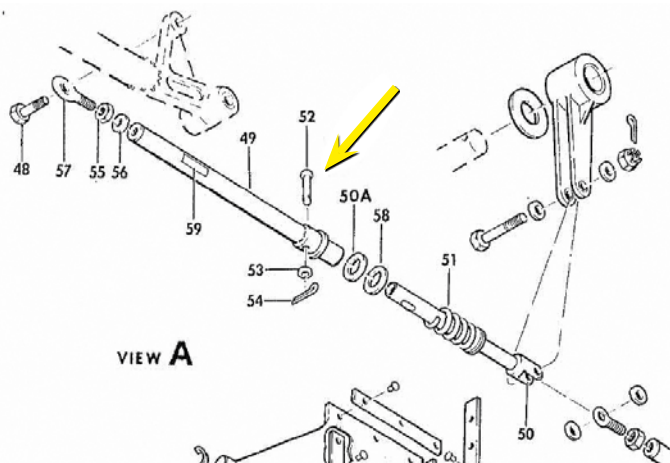
FIGURE 5

On early model Bonanzas, the rod #50 in **Figure 5** had a short nose. If/when pin #52 fails, upon gear retraction the rod slides out of its nested position in rod #49, which would pull the nose gear up. There you have the makings of a nose gear collapse on landing rollout. In February 1957, Beech issued a Service Letter announcing that a longer rod #50 and controlled-strength shear pin was used starting with Serial Number D-4547 (midway through 1956 G35 production). The Service Letter refers to retrofit kit #35-619 for earlier airframes. Read the entire Service Letter at www.csobeech.com/files/Beech-SB-NoseGearPin.pdf. A vintage Bonanza source recently called out the kit as P/N 35-8007-1S. The newer rod is reported to be 7.5" longer and is P/N 35-825094-4.

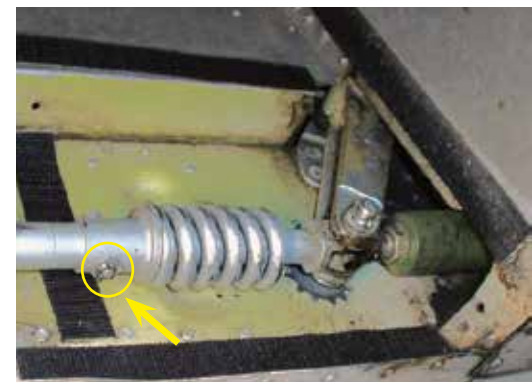
FIGURE 8

found "in the nick of time" to avert a landing gear disaster. As you can see from the assembly in **Figure 8**, without complete disassembly and inspection, the shear pin damage is impossible to detect.

Figure 8 shows the nose gear linkage assembly as installed. The pin is clearly visible but I think you'd be hard pressed to see potential mangling without complete disassembly. Come to think of it, why not just put a fresh new one in there and toss the 20-, 30-, 40-year-old

one in the trash? Also note that the tensioning spring has a reasonable amount of distance between coils. A spring that is “stacked,” with the coils very near or touching each other, should also be replaced.

The nose gear spring #51 (**Figure 8**) for my B55 is P/N 35-825188 and the main gear springs (one on each main gear lifting arm in the main gear wells) is P/N 45-815091. Check

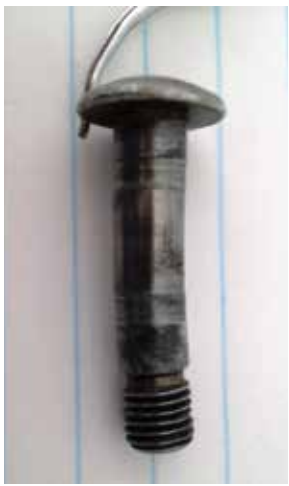
FIGURE 9

While we are still in the nose gear area, let’s take a look at **Figure 9**, which shows a bent bolt found by a savvy IA who was involved in a thorough gear disassembly inspection. This bolt connects the two nose gear rods to an idler at #50 in **Figure 5**.

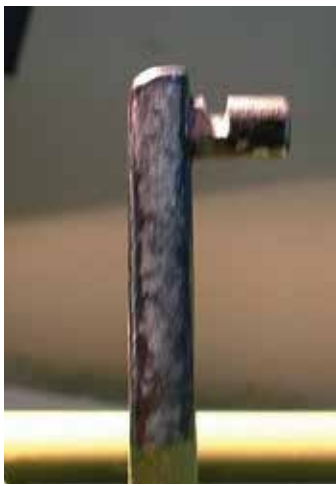
FIGURE 10

Let’s look at one more nose gear watch out: nose gear door actuator

pin as shown in **Figures 10** and **11** (**Figure 10** showing a pin worn nearly through). If this pin is lost the nose gear pickup fork (**Figure 12**) will not be actuated and the nose gear doors will not close. The repaired pin, done by welding, is shown in **Figure 11**. Sawing action between the pin and the pickup fork is the culprit. It helps to add a dab of grease to the pin.

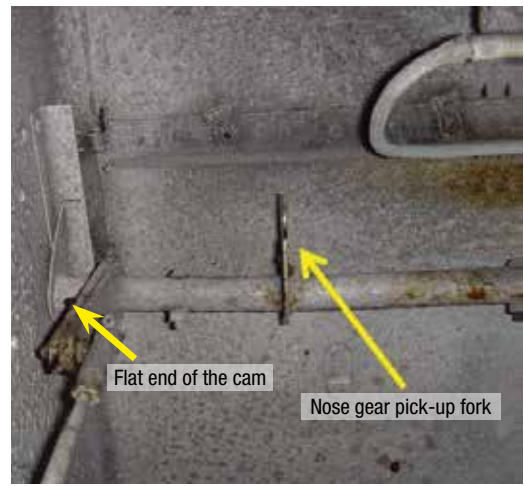
FIGURE 12

- In the nose gear (**Figure 12**), the flat end on the left side of the cam must be firmly planted on the “L” shaped piece that is on the left side (of this picture view, right side of the aircraft) of the inner wall when the gear is down and locked. If your gear door rods are ever removed it is easy to reattach them in such a way that the cam/pickup fork is slightly turned counter clockwise, and the flat part of the cam will not be flush with the “L” piece on the wall. You will then have nose gear doors that do not close properly, and also potentially bend the pickup fork by the pin on the down lock arm.

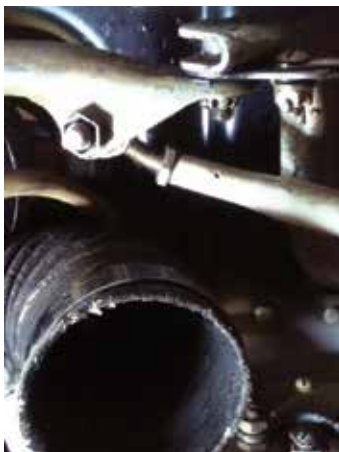
FIGURE 13

After disconnecting the inner gear doors from their rods, I've found it a great help to firmly safety wire a length of rubber hose on the end of the rods that is long enough to extend out the fuselage far enough to protect the rod throughout its full travel. Leaving the ends of the rods exposed when cycling the gear leaves them vulnerable to hanging up on something during their trip in and out. **Figure 13** illustrates what you don't want to have happen to your rods.

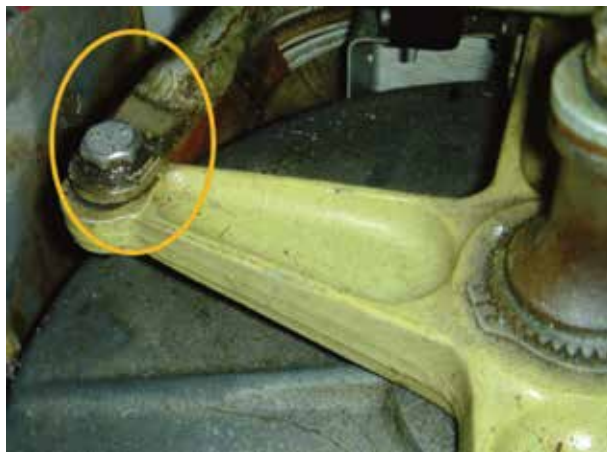
FIGURE 14

Inner main gear door slop can be caused by any number of factors: tired gear motor, improperly adjusted uplock and downlock micro switches, poor dynamic brake function, and wear in

the arm bushing and bolt combination. **Figure 14** shows the slight wear signature in the transmission arm that indicates bushing/bolt wear in the linkage. **Figure 15** and **16** show the bolt and bushing combination.

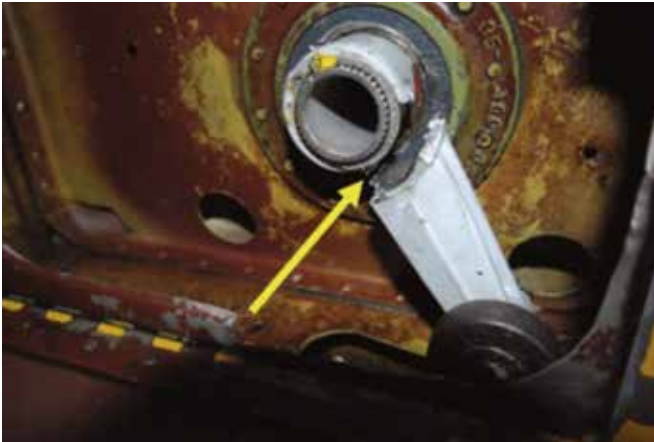
FIGURE 17

Another older airframe weakness is the thinner nose gear arm that was fitted to early Bonanzas (and T-34s). **Figure 17** shows a failed arm on the bottom of the gear transmission.

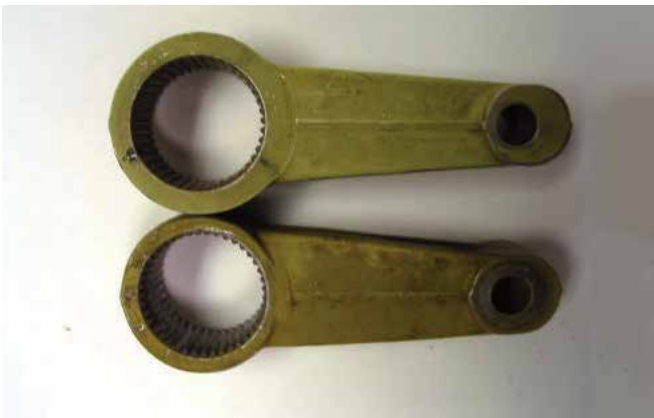
FIGURE 18

Beech has gone through three generations of these arms. The first few years it was made out of magnesium and was P/N 35-825172. Some time later Beech changed to an aluminum version, P/N 35-825172-2, used through the 1980s at which point they switched to the heavier-bodied arm, P/N 35-825172-13. **Figure 18** shows the more robust design alongside an earlier design.
