Landing Gear Notes

By Dick Pedersen, ABS Technical Advisor

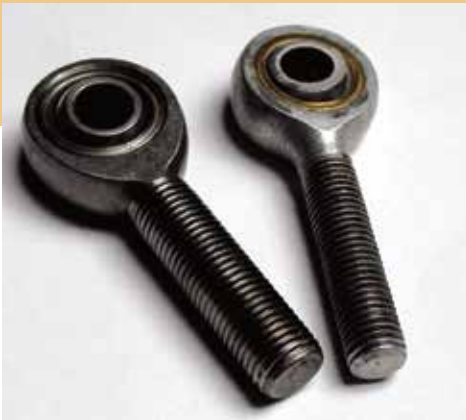
The larger 3/8" × 24 rod end is on the left, and the 5/16" × 24 rod end on the right, both of which are the solid shank types.

These HM-5 rod ends had only a 5/16" × 24 threaded shank that was hollow. Beech wanted them replaced as soon as possible with a solid shank version of the rod end, a HM-5S rod end. The added "S" to the part number stood for solid shank. When these planes were almost new I was just a little tyke helping my dad rebuild wrecked Bonanzas, and I can remember him ferrying several back to our shop with the nose gear braced down with a steel assembly he had fabricated just for that purpose. I remember him saying more were collapsing the nose gear as the rod end was breaking.

Later, Beech came out with a heavier rod end for these two locations, P/N HMX-5FG. The photo shows the difference in shank size. This started with the 1957 H35 according to the Beech Parts Catalogs. It only makes sense as the H-model had major structural changes throughout the entire airframe, with higher horsepower and gross weight among other things. This rod end has a larger 3/8" x 24 threaded shank; however, the shank was hollow again and included a grease fitting at the swivel

The rod end Beech now uses on new planes is a 3/8" x 24 solid shank rod end, P/N ADNE5-323. The Beech Maintenance Manual recommends the three rod ends on the nose gear retract system be replaced every 2,000 hours time-in-service (TIS). The ABS technical staff recommends the rod ends be replaced on this schedule with the solid shank style (like the late models) to further help prevent a nose gear failure.
