Beech on a Budget

Landing Gear System Watch Outs

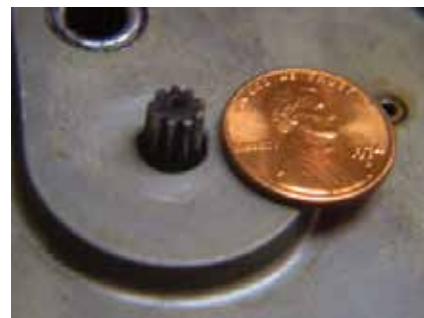
FIGURE 1

The landing gear system in our ABS airframes is nothing short of an engineering marvel, both mechanically and electrically. Simply considering that a DC motor a little larger than a man's fist with a gear shaft diameter smaller than a penny (**Figure 1**) is capable of lifting the unsupported weight of our wheels, brakes, and tires, and then extending the same under the air-speed loads we fly is quite impressive. This electro-mechanical system is essentially the
