Landing Gear Notes

By Dick Pedersen, ABS Technical Advisor

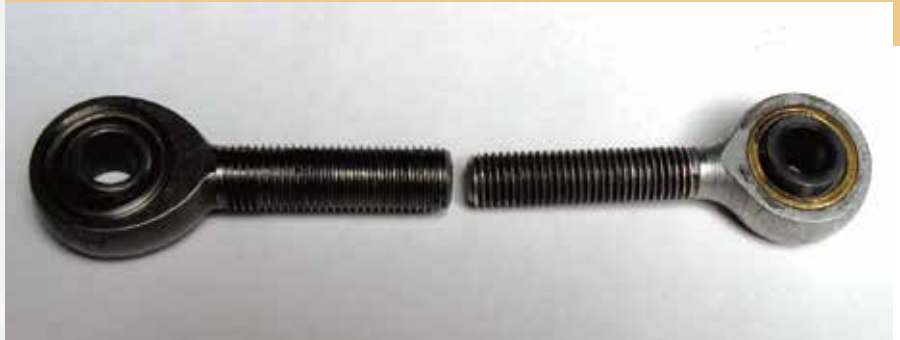
The larger 3/8" × 24 rod end is on the left, and the 5/16" × 24 rod end on the right, both of which are the solid shank types.

These HM-5 rod ends had only a 5/16" × 24 threaded shank that was hollow. Beech wanted them replaced as soon as possible with a solid shank version of the rod end, a HM-5S rod end. The added "S" to the part number stood for solid shank. When these planes were almost new I was just a little tyke helping my dad rebuild wrecked Bonanzas, and I can remember him ferrying several back to our shop with the nose gear braced down with a steel assembly he had fabricated just for that purpose. I remember him saying more were collapsing the nose gear as the rod end was breaking.

The rod end Beech now uses on new planes is a 3/8" x 24 solid shank rod end, P/N ADNE5-323. The Beech Maintenance Manual recommends the three rod ends on the nose gear retract system be replaced every 2,000 hours time-in-service (TIS). The ABS technical staff recommends the rod ends be replaced on this schedule with the solid shank style (like the late models) to further help prevent a nose gear failure.

I have found several of the hollow shank rod ends bent during my retract system inspections. When I replace these rod ends for my customers I also replace the rod

If you own a 35 thru G35, it probably wouldn't be a bad idea to have your shop check the two forward rod ends to be sure they are the correct solid shank type...

ends on the main gear retract system, as I have also found several of those bent. These were also originally hollow shank rod ends, which I replace with the latest Beech P/N 131553FG6M rod ends (solid shank). There is just one rod end on each main gear retract rod, at the outboard end.
